Carburisation of Fe–Ni–Cr alloys at high temperatures

A. UL-HAMID^{1*}, H. M. TAWANCY¹, S. S. AL-JARUDI²,
A. I. MOHAMMED¹, N. M. ABBAS¹

A large number of radiant tubes belonging to an ethylene furnace of a petrochemical plant failed during service. All tubes exhibited severe carburisation, while some of them lost their structural integrity and sagged. The tube material was based on a Fe–Ni–Cr alloy system with three varying compositions. Scanning electron microscopy and energy dispersive X-ray spectroscopy were used to characterize the microstructure and elemental composition of the tube material. Microhardness was tested to determine their mechanical strength. Experimental results indicated that the sagged tubes exhibited a higher degree of carburisation as compared to other tubes. The microstructure of these tubes also revealed coarser Cr-carbide precipitation and a continuous carbide lattice at austenite grain boundaries. It was concluded that exposure to excessive temperature during service was responsible for the degradation of all tube materials. Based on the above results, it is recommended that better control of furnace temperature should be employed in order to avoid ove

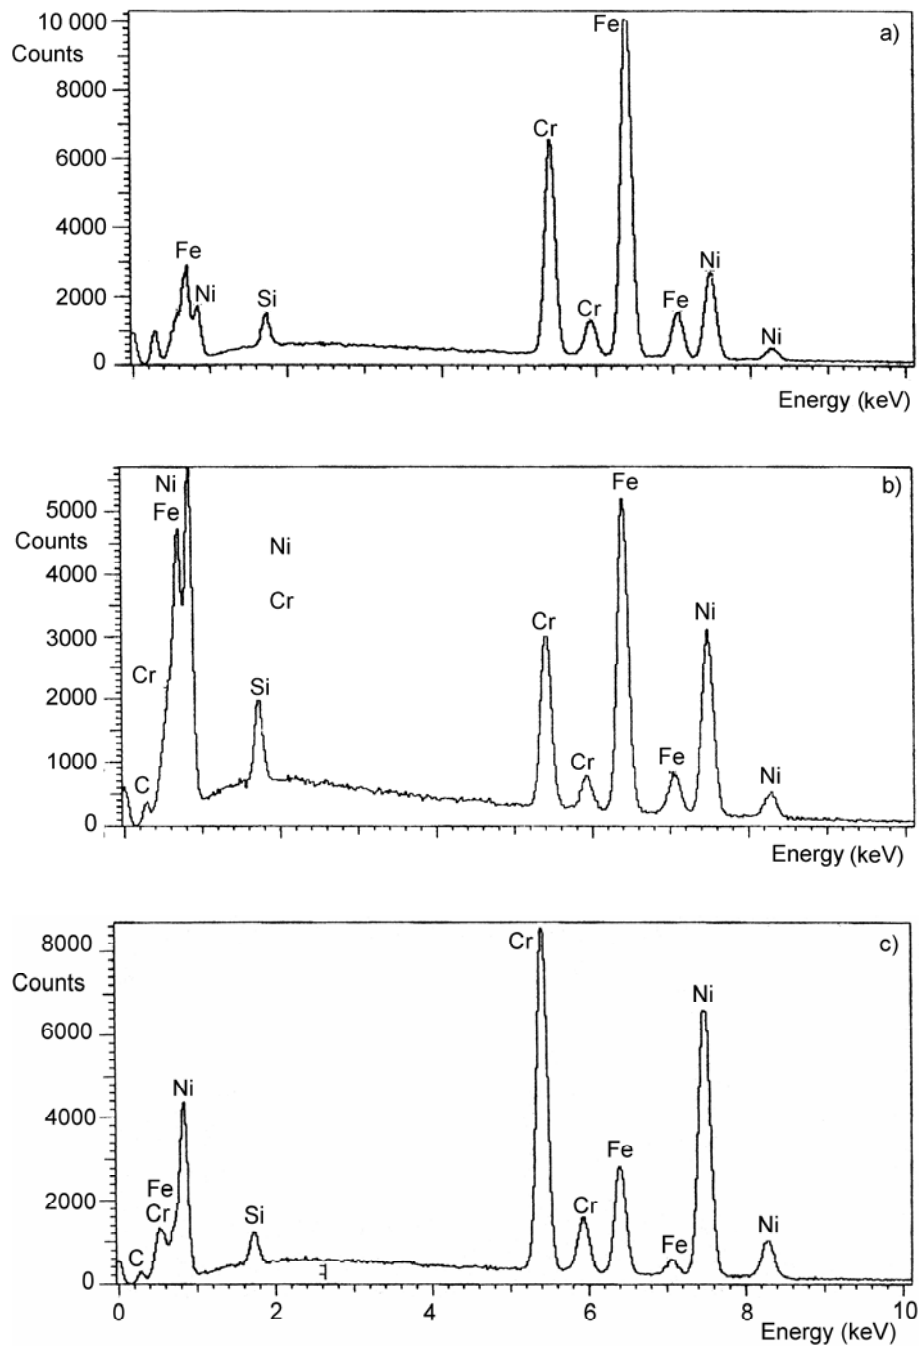
Elemental analysis of each tube sample was performed using energy dispersive X-ray spectroscopy. Representative EDS spectra and measured compositions for each tube material, along with its nominal composition, are shown in Figs. 1a–c and Table 1. The difference in composition between the nominal and measured values is expected due to the exposure of tube material to elevated temperatures in service. This exposure results in the precipitation of M-carbides (where M is Cr, Nb) within the matrix and at the grain boundaries, thus altering the starting composition of the matrix. Within this limitation, the measured composition can be seen to be in agreement with the nominal composition, confirming the tube materials are HK-40 (for tubes 1-2), HP 25Cr-35Ni Micro Alloy (for tubes 3-6), and 35Cr-45Ni Micro Alloy (for tubes 7-9). Based on the nominal composition, these alloys are suitable for the kind of service conditions encountered in an ethylene furnace. Alloy HK-40 is Ni-Cr grade, suitable for low stress reformer catalyst tube designs with service temperatures up to 1025 °C. Increased levels of silicon provide improved carburisation resistance, to benefit low severity ethylene cracking furnace coils. Alloy HP 25Cr-35Ni MA is a micro-alloyed HP with small additions of Ti and rare earth elements, which is especially stable at high temperatures. This alloy forms tenacious oxide films that reduce surface oxidation at temperatures of 1150 °C. The third alloy, 35Cr-45Ni MA, can be used up to 1150 °C and possess good high temperature strength and carburisation resistance. This micro-alloy offers improved aged ductility and resistance to metal dusting. It is quite suitable for components operating in the hot zones of pyrolysis coils and components of reformer outlet manifolds.

Fig. 1. Energy dispersive X-ray spectra derived from an uncarburised austenite region for verifying the furnace tube material: a) sample No. 2, b) sample No. 5, c) sample No. 8

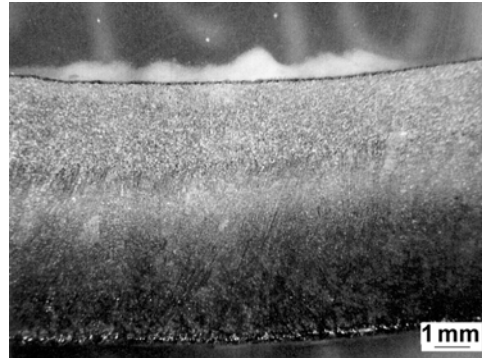
A typical optical macrograph of a tube cross-section obtained from sample No. 1 is shown in Figure 2. The carburised zone was about 8 mm in depth. The average carburised depth in samples No. 1 and 2 was observed to be 22% of the tube wall thickness.

Fig. 2. Optical macrograph of a tube cross-section obtained from sample No. 1 showing the carburised region

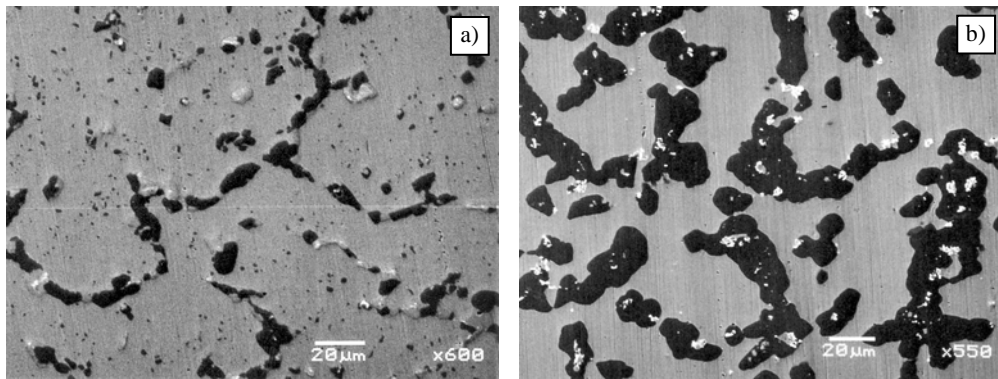
Fig. 3. Secondary electron SEM image obtained from (a) uncarburised and (b) carburised regions of sample No. 1

The microstructure of the uncarburised region is shown in a secondary electron SEM image in Figure 3a. The tube material consisted of relatively large equiaxed grains with precipitation at the grain boundaries. Energy dispersive X-ray spectroscopy revealed that the matrix was comprised of austenite (Fe–Cr–Ni solid solution) and that the grain boundary constituted a Cr-rich carbide. The austenite matrix also revealed the presence of coarse and fine particles of Cr-rich carbides. The microstructure of the carburised region for the same sample is shown in Figure 3b. It can be observed that the Cr-rich carbide precipitates present within the austenite grains are coarser in size compared to those in the uncarburised region.

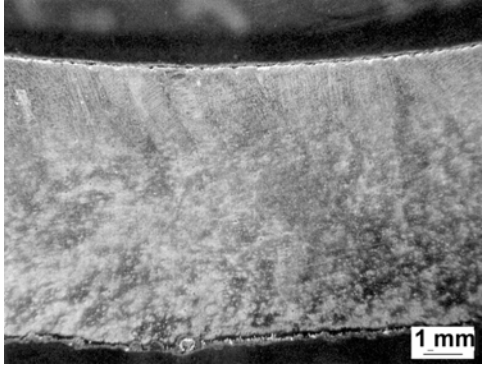
Figure 4 shows the optical macrograph of a tube cross-section from this group of tubes (Nos. 3–6). It can be seen that more than 50% of the wall thickness exhibited signs of carburisation.

Fig. 4. Optical macrograph of a tube cross-section from sample No. 5 showing the carburised region

All the furnace tubes examined in this study exhibited carburisation. The average depth of the carburised zones in furnace tubes Nos. 3–6 was 58% of the total wall thickness, as compared to 22% for tubes Nos. 1–2 and 26% for tubes Nos. 7–9. Moreover, visual examination also revealed that tubes Nos. 3–6 were clearly sagged, indicating significant plastic deformation during service. Clearly, tubes Nos. 3–6 exhibited the most severe degradation amongst the studied samples. This was also confirmed by SEM/EDS examination, in which the microstructures of tubes Nos. 3–6 exhibited relatively coarse blocky carbides within the austenite matrix and a continuous carbide lattice at the grain boundaries. Massive precipitation of carbide phases is typical of carburisation [5, 6]. These observations suggest that the alloy had been exposed to an excessively high temperature during service. The hardness of the carburised zone was also found to be higher in tubes Nos. 3–6 as compared to the other tube materials, indicating a higher precipitation and C pickup by the alloy. The deposition of coke on the inner pipe wall also promotes C diffusion and the precipitation of secondary carbides within the alloy. As demonstrated earlier under the operating conditions, the tube alloy develops a non-protective surface oxide scale. Carbon deposited on the surface can readily penetrate the oxide scale into the alloy substrate, where it reacts with carbide-forming elements, particularly Cr, to form the observed Cr-rich carbides.

The temperature of the furnace should be controlled closely, in order to avoid over-heating during ethylene production and decoking.

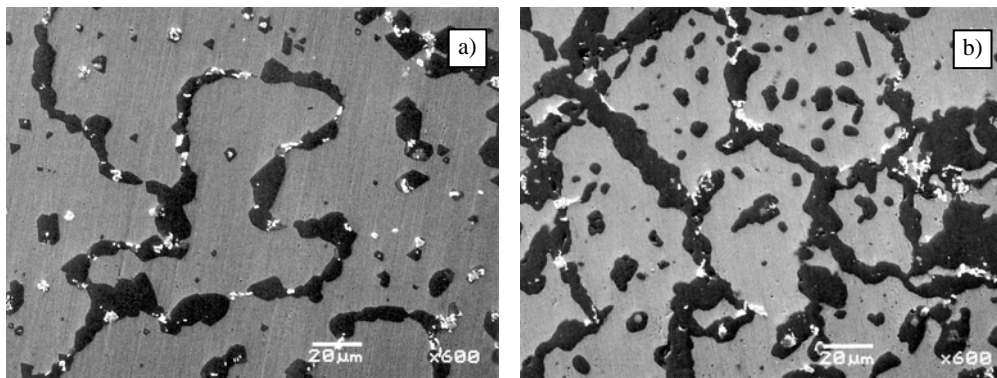
Fig. 5. Secondary electron SEM image obtained from uncarburised (a) and carburised (b) regions of tube sample No. 5

A typical microstructure obtained from an uncarburised region of tube sample No. 5 is shown in the secondary electron SEM image in Figure 5a. Compared to the uncarburised region of tube material No. 1 (see Figure 3a), the carbide precipitation appears relatively coarse both at the austenite grain boundaries and within the matrix itself. This is confirmed by the EDS analysis in which the Cr concentration was determined to be as low as 13 wt. % at various regions within the austenite. The depletion of Cr within the matrix indicates the tendency of Cr to diffuse and form Cr-rich carbides at the austenite grain boundaries and/or coarsen pre-existing carbides within the austenite. The diffusion of Cr is enhanced at elevated temperatures. The higher the temperature, the greater the carburised zone and the coarser the carbide precipitates.

The carburised region from the same sample shows a high degree of carbide precipitation at the grain boundaries and blocky carbide particles in the matrix as shown

by the SEM image in Figure 5b. The grain boundary precipitate predominantly comprises Cr, as shown by the EDS spectrum in Figure 6a, and is present in the form of a continuous lattice. The white precipitates adjacent to the grain boundaries are Nb-rich, as shown by the EDS spectrum in Figure 6b.

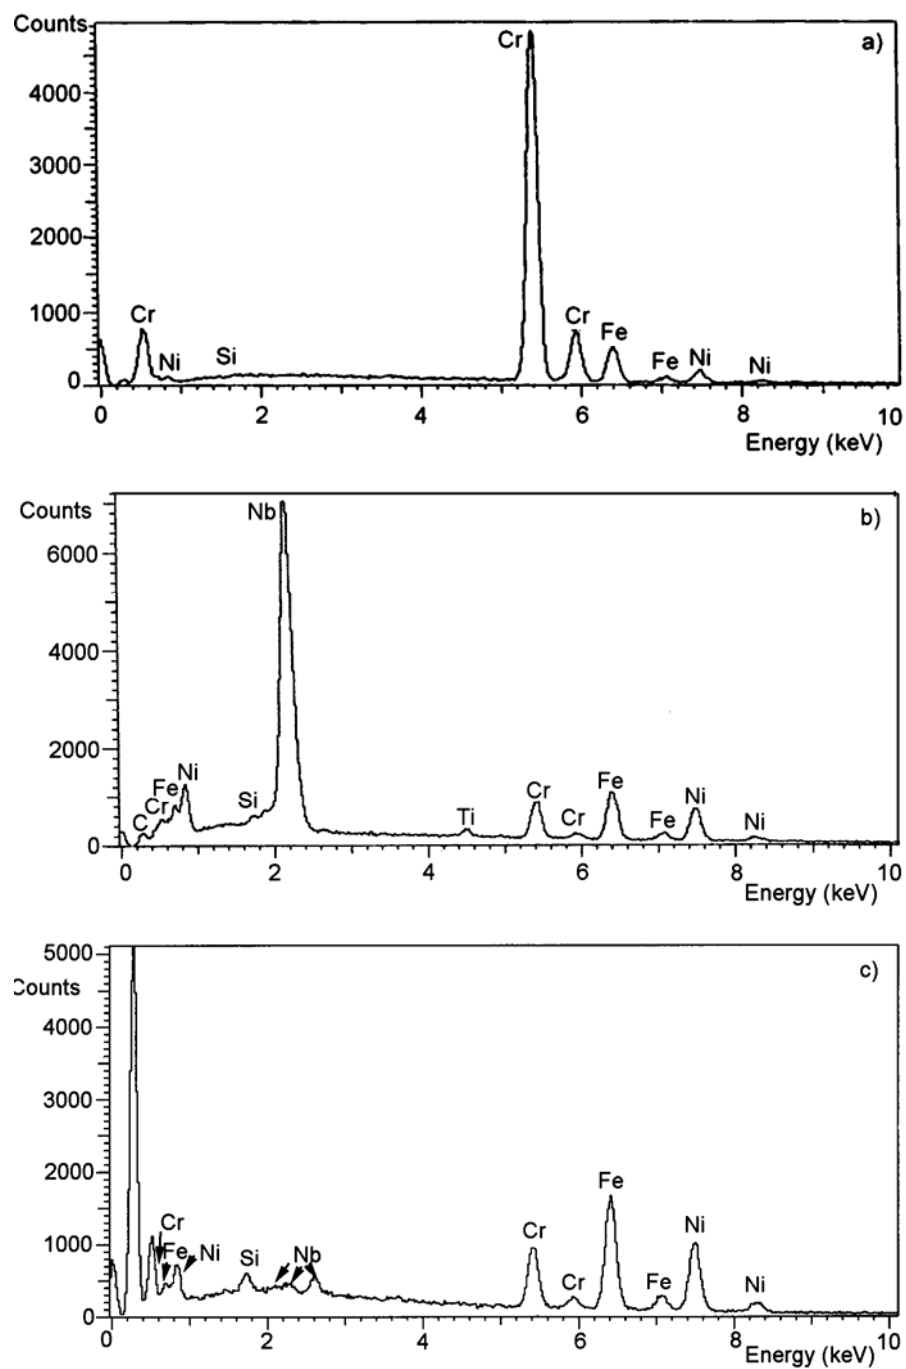
Fig. 6. Energy dispersive X-ray spectra obtained from grain boundary precipitates exhibiting Cr enrichment (a), white precipitates exhibiting Nb enrichment (b), and a carburised region near the tube inner surface (c)

EDS analysis of the carburised region near the inner tube surface (Fig. 6c) showed high C content; the quantified results are summarized in Table 2. Massive carbide precipitation at the austenite grain boundaries (forming a continuous lattice) and the presence of carbides as coarse blocky particles within the matrix indicate the exposure of the furnace tubes to an excessively high temperature that leads to heavy carburisation.

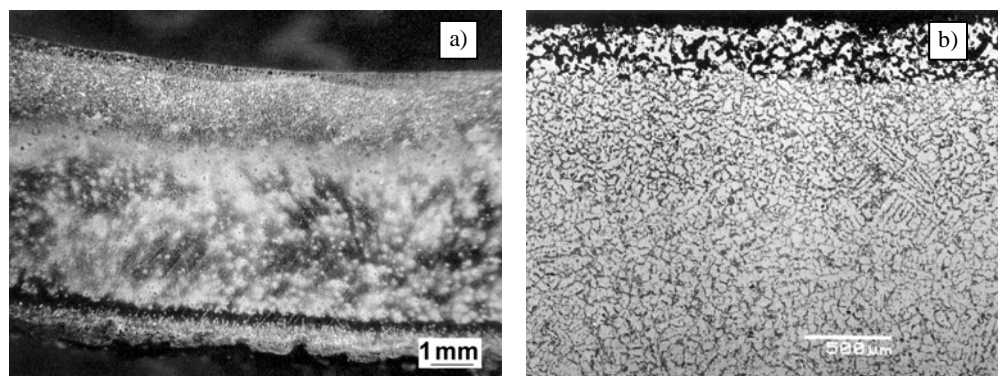
Optical and SEM micrographs of the cross-section of tube No. 9 are shown in Figures 7a, b, respectively. The carburised region was approximately 26% of the wall

Fig. 7. Optical (a) and SEM (b) micrographs of the cross-section of tube No. 9 showing a carburised region

thickness in these samples. Typical microstructures obtained from the uncarburised and carburised regions of the furnace tube material (Nos. 7–9) are shown in Figures. 8a, b, respectively. The microstructures comprised dark Cr-rich and white Nb-rich precipitates, along with greyish precipitates comparatively richer in Ni as shown by the EDS spectrum in Figure 9 and chemical composition in Table 3.

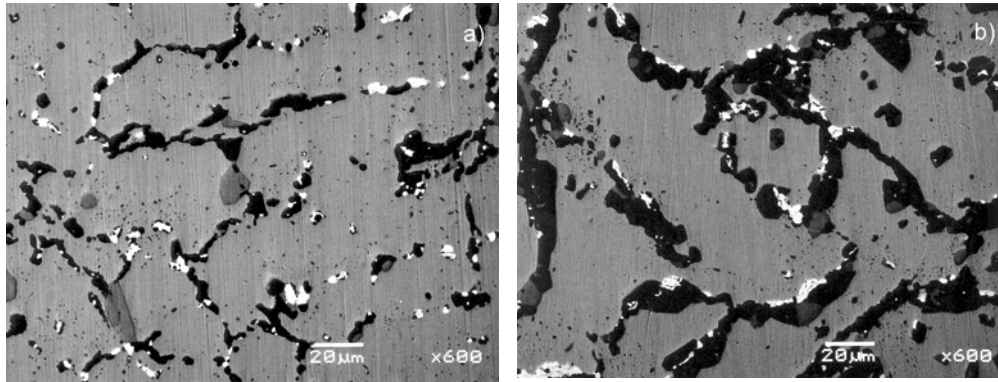
Fig. 8. Secondary electron SEM image obtained from uncarburised (a) and carburised (b) regions of tube sample No. 8

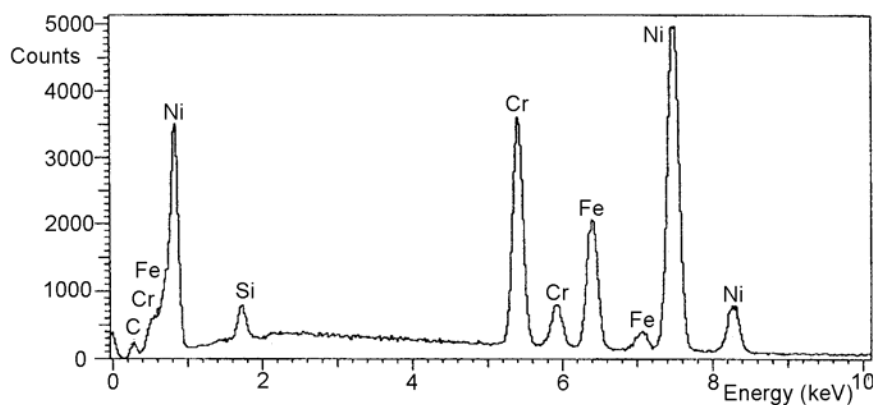
Fig. 9. Energy dispersive X-ray spectrum obtained from light grey precipitates, showing a large peak for Ni

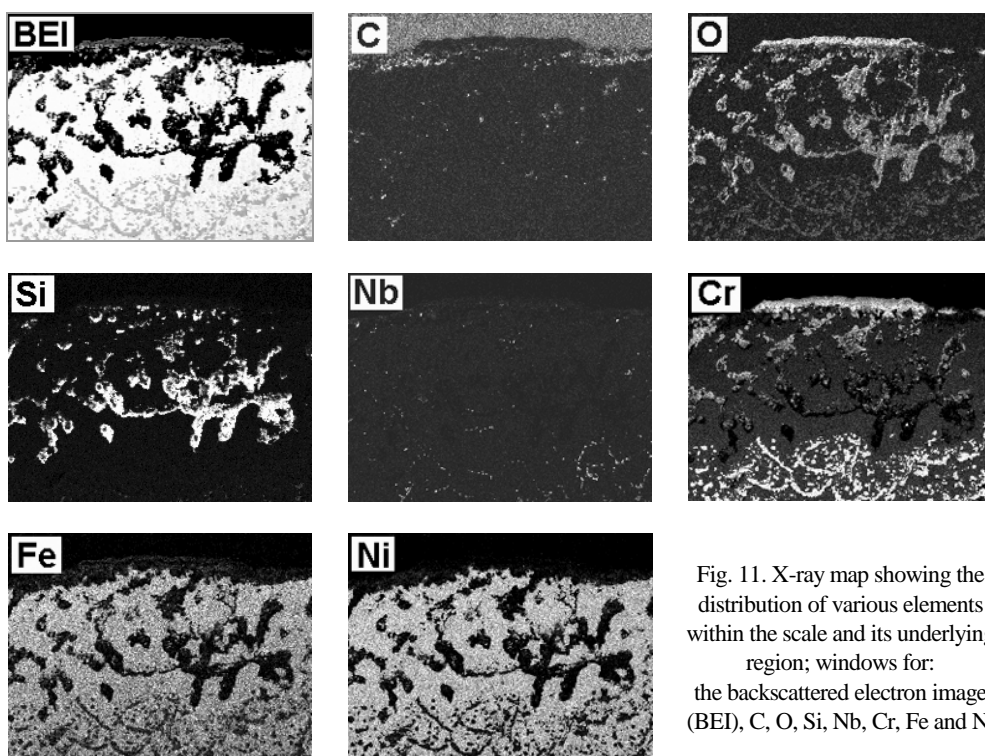
A typical morphology of the scale formed at the internal surface of the furnace tubes is shown in the backscattered electron SEM image in Figures 10, 11. The scale was discontinuous and broken, thus providing minimal protection to the underlying alloy from diffusing species. The X-ray map and various EDS spectra obtained from the region (Fig. 11) revealed that the oxide formed at the surface was Cr-rich, while Fe and Ni could also be detected in the scale. In addition, Si and to some extent Cr-rich oxides were detected at the austenite grain boundaries just below the alloy surface. The Cr content of the austenite grains in this region was as low as 4.2 wt. %, which is inadequate to sustain a continuous protective Cr_2O_3 scale.

Fig. 11. X-ray map showing the distribution of various elements within the scale and its underlying region; windows for: the backscattered electron image (BEI), C, O, Si, Nb, Cr, Fe and Ni

Based on the above observations, it can be concluded that the alloys were incapable of developing a protective oxide scale. This could partly be due to the relatively low oxygen potential of environments typically encountered in ethylene production. The presence of a protective oxide scale can impede C diffusion into the alloy and play an important role in reducing the extent of carburisation. Earlier studies of carburisation have shown that in severely carburising environments, where the carbon activity reaches 1, Cr_2O_3 -forming alloys develop surface carbide scales rather than oxide scales [3]. It is evident from the above results that the oxygen potential of the environment promoted the formation of an oxide scale. The scale was not protective, however, as indicated by the presence of voids, which permitted the penetration of carbon into the alloy substrate.
